PROBLEM *Solver*[™] BULLETIN

Premature Tie Rod End Failure

1995-2003
Ford Windstar

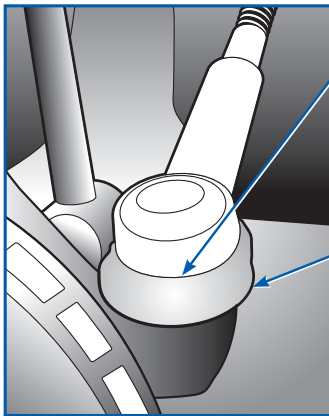
Water and contaminants leak past the boot retaining ring, causing corrosion and accelerated wear. Original non-serviceable design is unable to flush contaminants.

Water gets trapped in lip of dust boot, then seeps past retaining ring.

Inspection: With vehicle on the ground, have an assistant rotate the steering wheel back and forth. Observe the tie rod ends for movement. A tie rod exhibiting any perceptible movement should be replaced. Per revised manufacturer's inspection procedure, lift the bottom of the boot and inspect the tie rod stud. The part should be replaced if there is any sign of water or corrosion.
