PROBLEM *Solver*[™] BULLETIN

Lower Ball Joint Failure

Chevrolet Trailblazer, GMC Envoy, Oldsmobile Bravada, Buick Rainier, Saab 9-7X and Isuzu Ascender

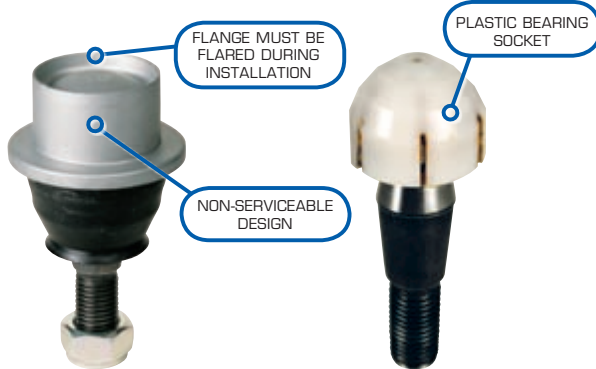
Lower ball joints fail prematurely

- Original equipment stud ball diameter and OE-style polymer bearing do not provide sufficient load-carrying capability, especially in rough service conditions.
- Non-serviceable polymer sockets cannot flush contamination, which quickly leads to corrosion and wear.
- Load stress and intrusion quickly erode the bearing surface.
- OE-style replacement ball joints require special tools during installation to flare the retention flange.

Be sure to remove old OE-style ball joint flange. It must be bent upward for removal.
