Solver[®]
BULLETIN

Clunking from Front End

2000-2004 Ford F250 Super Duty, F350 Super Duty, F450 Super Duty, F550 Super Duty trucks

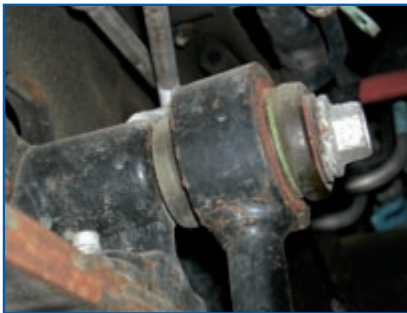
Failure of OE bushing-style sway bar links

The OE sway bar link has been known to fail in as little as 40,000 miles, particularly if it's been subjected to severe and off-highway use. The cross-axis joint design acts as a mini socket, which rotates in plastic bearings. The socket becomes worn and loose, causing a clunking noise and handling issues. In addition, the part's relatively small bar diameter has led to some breakage problems.
